The pilotage paradox

Cosco Busan

Captain Paul Drouin MNI

This article looks at underlying issues of the interaction between the bridge team and the pilot which may have contributed to the outcome.

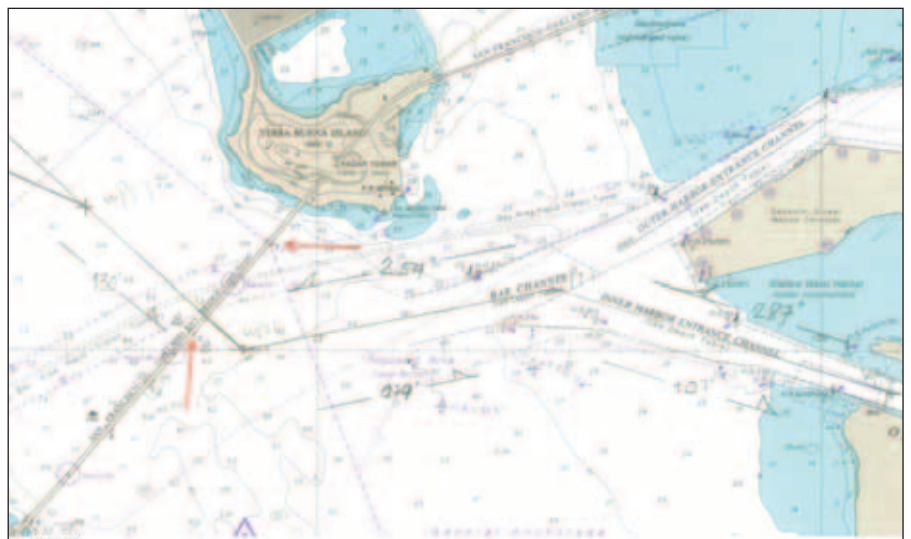
▲ *Cosco Busan* chart of San Francisco-Oakland Bay with courses indicated

While some controversy remains as to whether or not a passage plan existed for the outbound voyage, for what it is worth and thanks to the NTSB's public docket, it can be seen that courses seem to have been left on the ship's chart after the inbound voyage, and reciprocal courses would indicate an intended outbound route. The red arrows were added by the NTSB to point out the bridge pylons Delta and Echo.

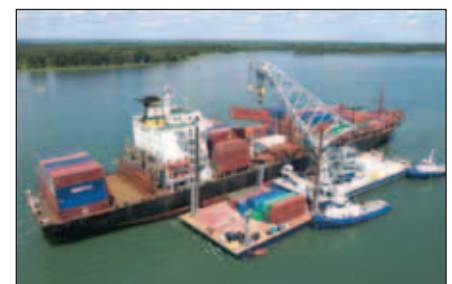
▲ *Horizon* being lightered (from TSB report)

pilot's performance was probably affected by fatigue but the OOW could not correct the situation in time because he did not have the tools or the information to do so. Although damage to the vessel was minimal and no pollution ensued, a costly salvage operation was necessary, with 109 containers having to be offloaded before refloating could be successful.

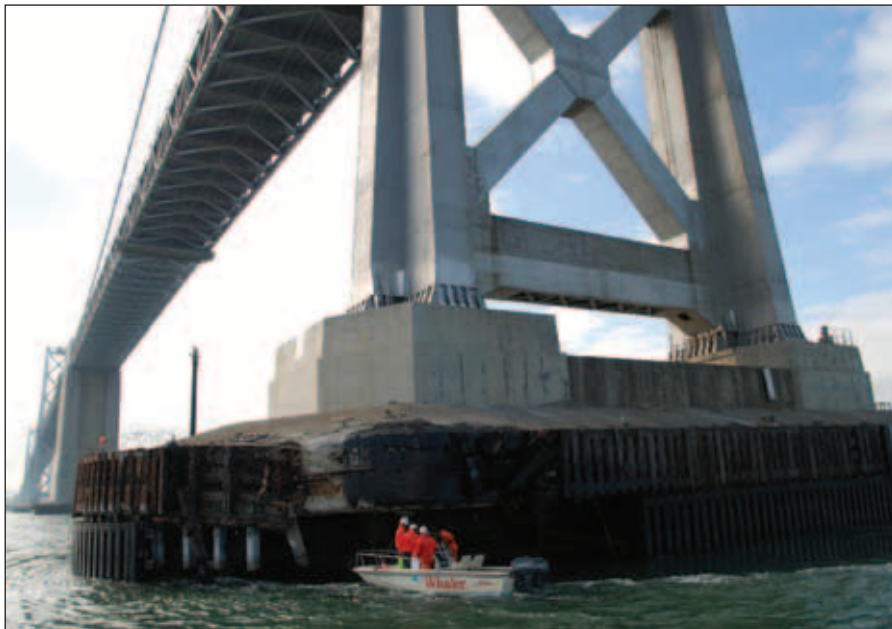
▲ From USCG 11th District Public Affairs, bridge damage survey video, Delta pylon fendering.
