# The lifeboat imbroglio

## Captain Paul Drouin MNI

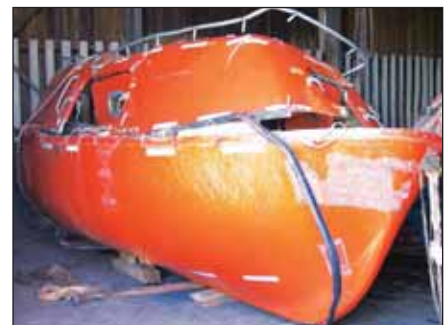
▲ Figure 2: A confused heap or tangle photo from Australian Transport Safety Bureau report 208 - *Lowlands Grace*

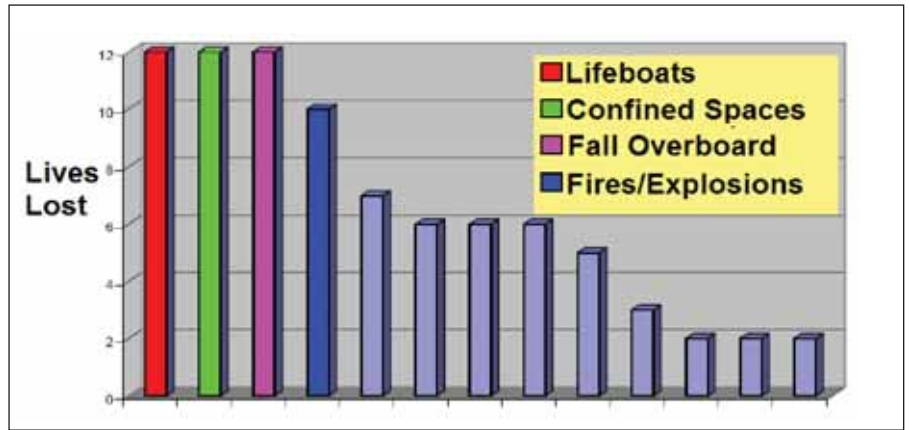
▲ Table 2: Causes of accidents **NB Source to be added**

This same study found that the root cause of many of the accidents was the over-complicated design of the lifeboat launch system and its component parts, which in turn required extensive training to operate. It identified that training, repair and maintenance procedures fell
